INSPECTION REPORT

For the Property at:
6414 IMPERIAL RD
100 MILE HOUSE, BC

Prepared for: JOHN DOE
Inspection Date: Friday, May 29, 2009
Prepared by: Daryl Silverton

RE: Report No. 1001
6414 Imperial Rd
100 Mile House, BC
V0K2E0

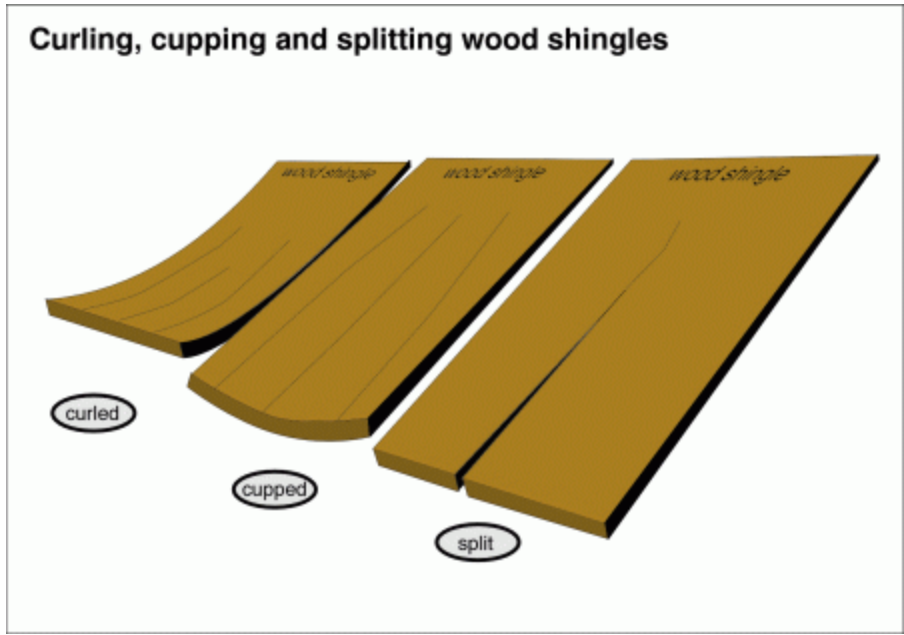
Sloped roofing \ Wood shingles and shakes

Condition: • [Old, worn out](#)

Implication(s): Chance of water damage to contents, finishes and/or structure

Location: Throughout

Curling, cupping and splitting wood shingles

Task: Replace

Time: Less than 1 year

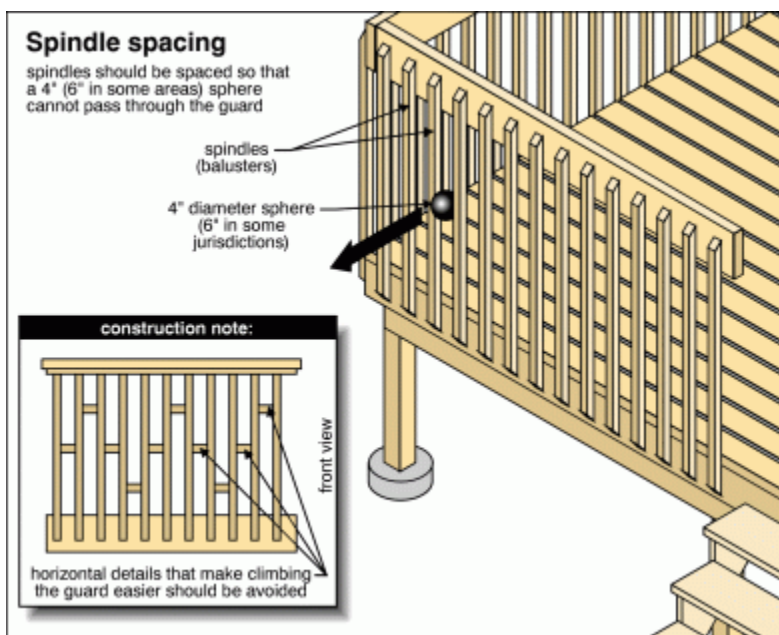
Porches, decks, steps, patios and balconies \ Handrails and guards

Condition: • [Spindles missing](#)

Implication(s): Fall hazard

Location: Third Floor Deck

Task: Improve

Time: Immediate

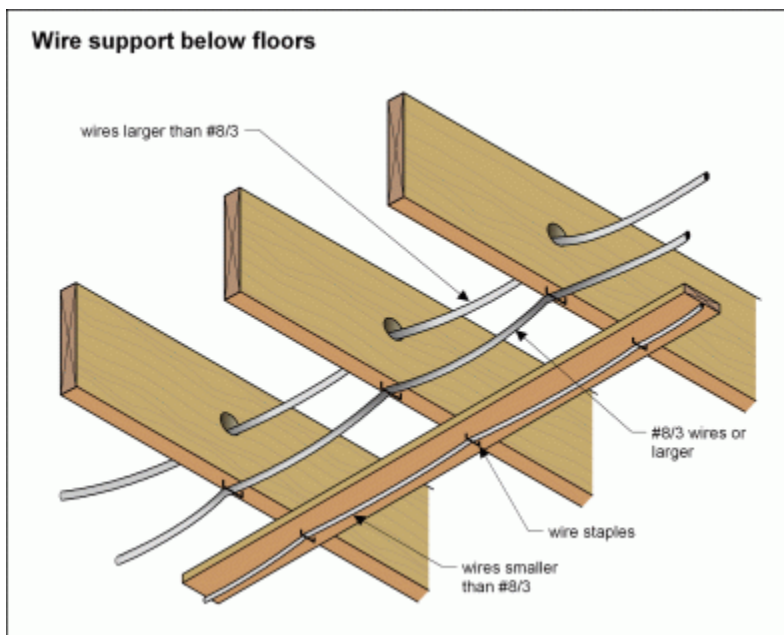
Distribution system \ Wiring - damaged or exposed

Condition: • [Exposed on walls or ceilings](#)

Implication(s): Electric shock

Task: Correct

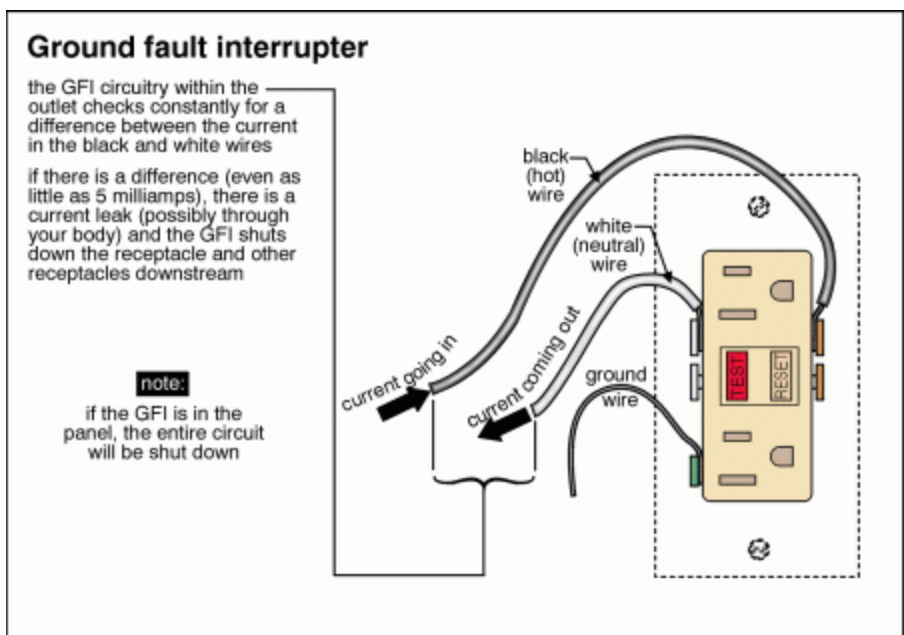
Distribution system \ Outlets

Condition: • [No GFI \(Ground Fault Interrupter\)](#)

Implication(s): Electric shock

Location: Kitchen

Task: Provide

Time: Discretionary

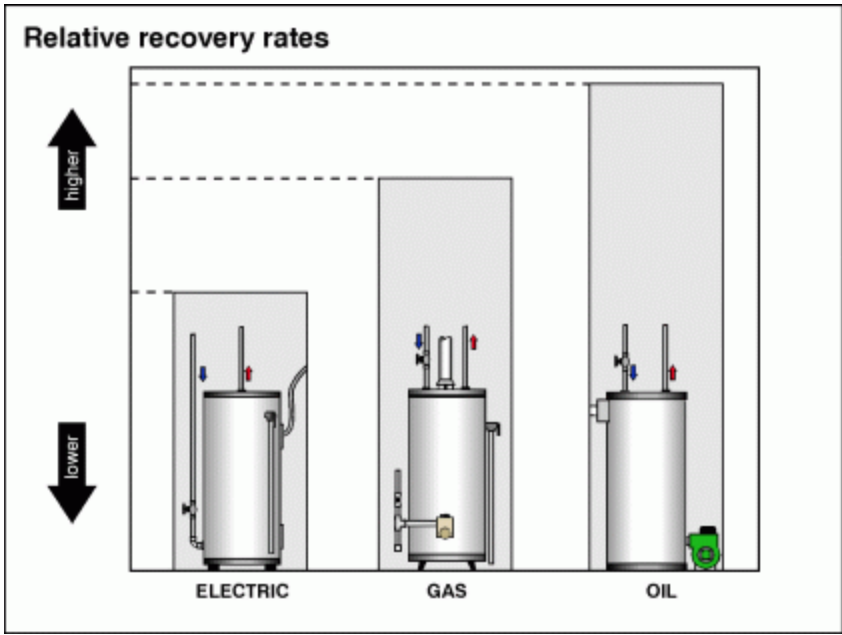
Water heater \ Capacity

Condition: • [Inadequate](#)

Implication(s): Inadequate domestic hot water

Time: Immediate
